ESB Asset Development UK Limited

# Chleansaid Wind Farm: Peat Slide Risk Assessment

Technical Appendix 10.1

655007-P10.1 (00)

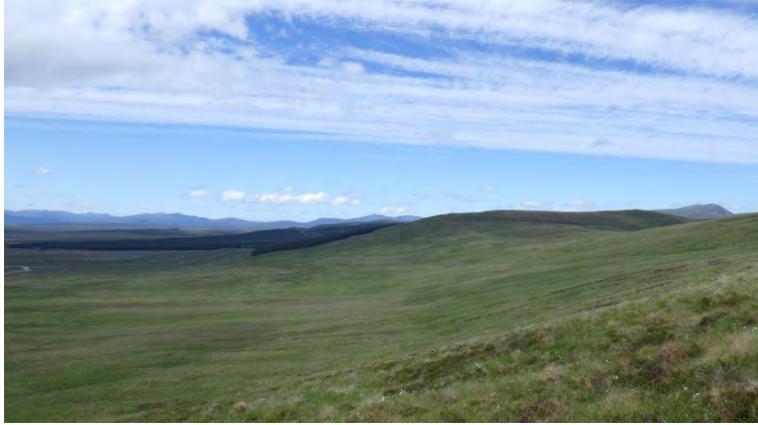
<p><b>(A) View of northern turbine area, NGR NC 6170 2830</b></p> <p>View looking NW along Leathad Chleainsaid.</p> <p>View includes the northernmost turbine area (Turbines T15 and T16).</p> <p>Peat along the hillside was generally shallow or absent with occasional records up to 1.5 m. In the lower area, peat was more variable – mainly &lt;1 m but in places deeper than 4 m.</p>

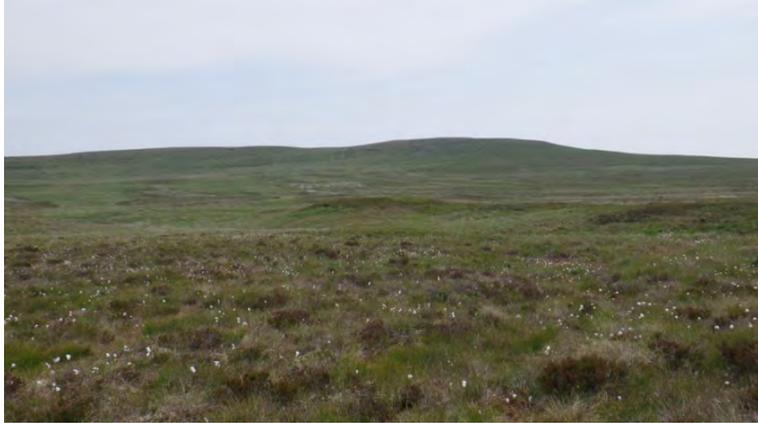
<p><b>(B) View of central turbine area, NGR NC 6040 2790</b></p> <p>Overview of central turbine area, including Turbines T11 and T9, looking east from the western planning application boundary.</p> <p>Peat depth in foreground is 1.9 m deep, becoming shallower around the watercourse, and then deepening further east.</p>

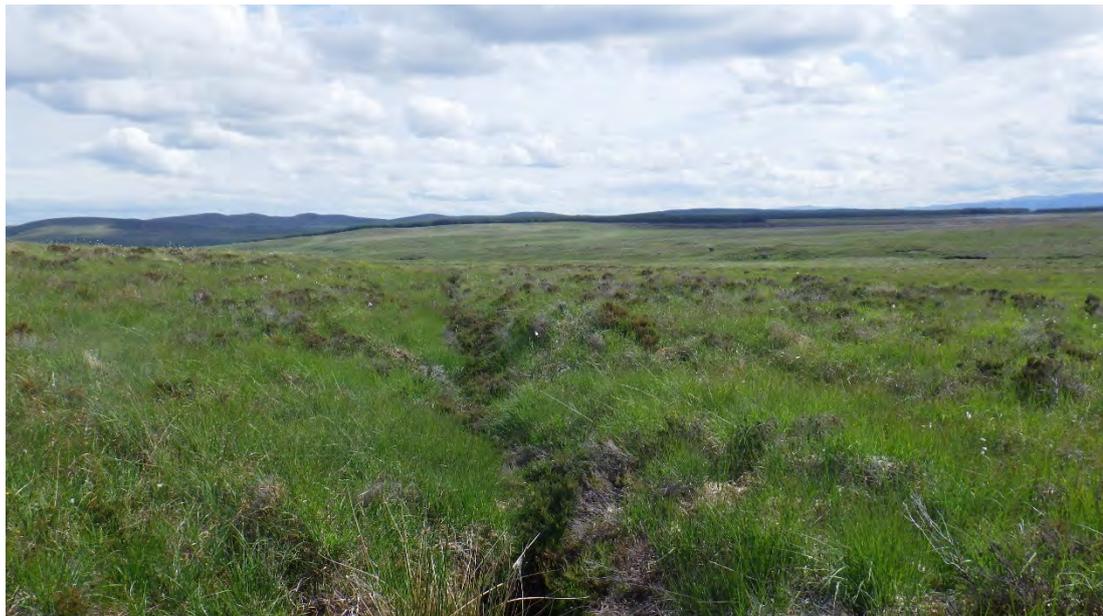
**Photograph 10.1.1: Drainage ditch on the lower slopes of Leathad Chleansaid, looking SSE from NGR NC 6140 1740.**

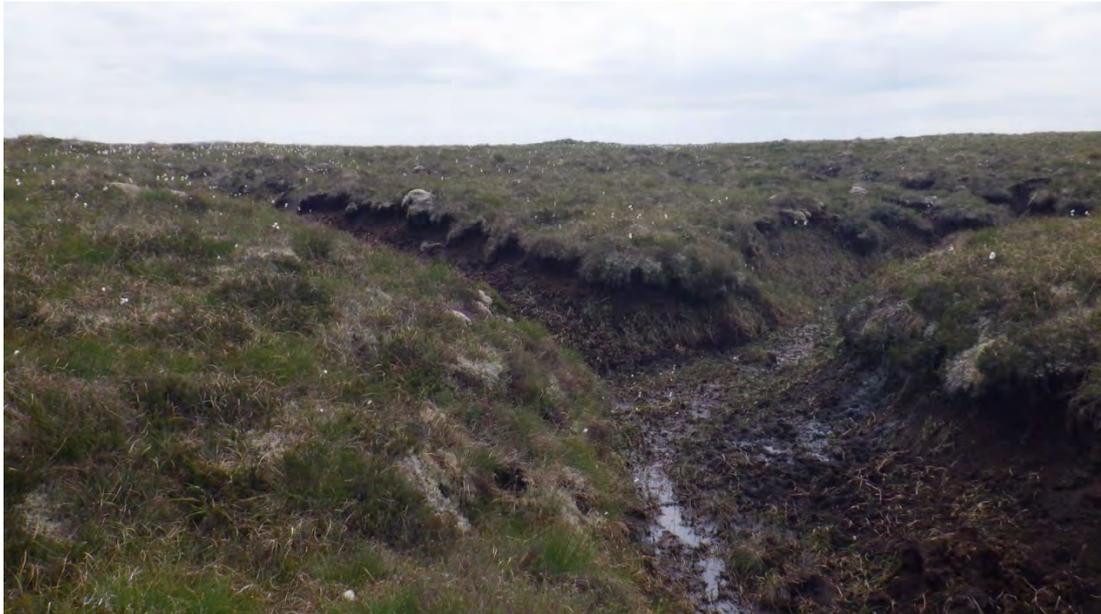
**Photograph 10.1.2: Peat hagg and active erosion in the turbine area near Turbines T3 and T4 (NGR NC 6109 1695).**

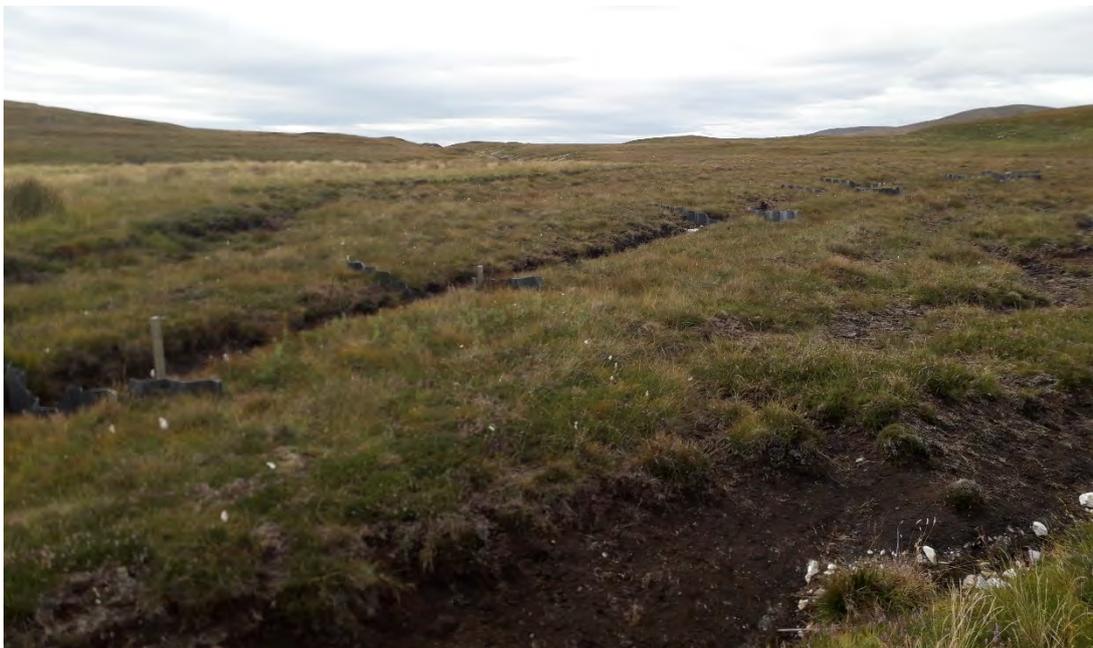
**Photograph 10.1.3: Existing peatland restoration at the Dalnessie Estate, to the south-east of the turbine area (NGR NC 2686 1572).**

- 5.11 Existing peat dams were observed to the south-east of the turbine area in September 2020, to the west of the existing access track (Photograph 10.1.3). This is part of other peatland restoration works that have been put in place within the wider estate. However, high levels of deer grazing and trampling pressure were also observed in this area during the May 2021 site visit which could negatively affect restoration attempts.

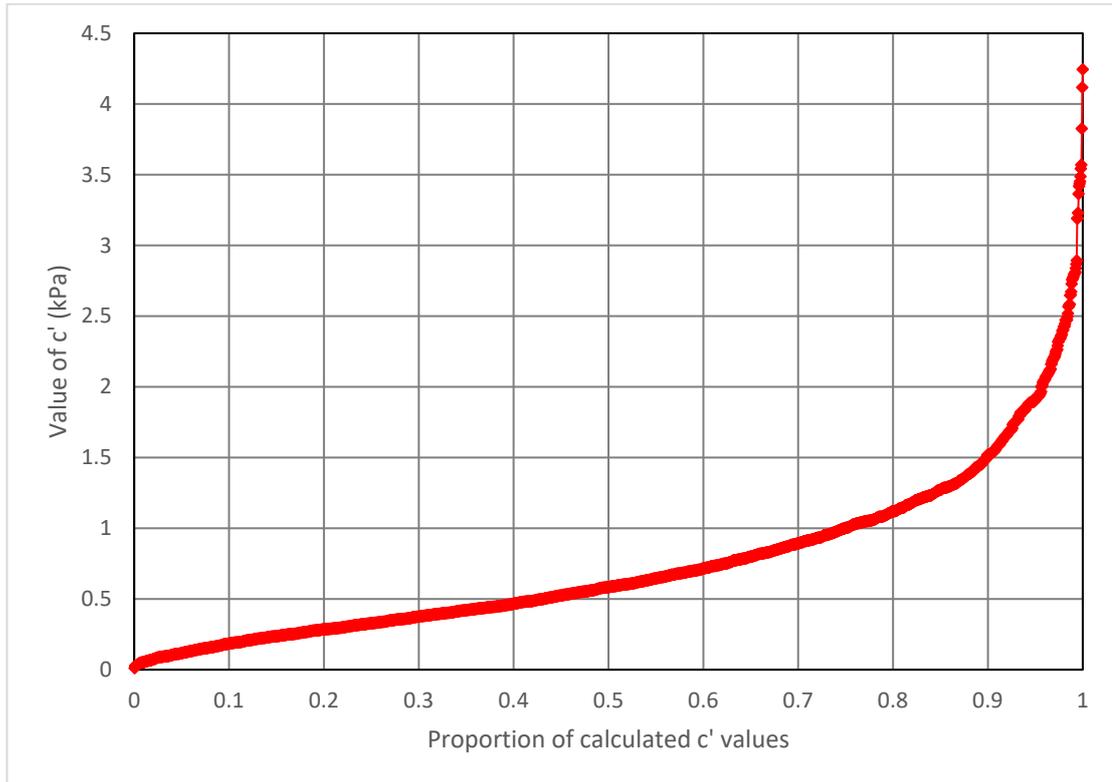
**Graph 10.1.1: Estimate of minimum shear strength, c'**

- 6.9 At the Proposed Development, 2,046 locations have been probed during the phases of fieldwork. c' values have been calculated for each of these and the distribution is provided in Graph 10.1.1.

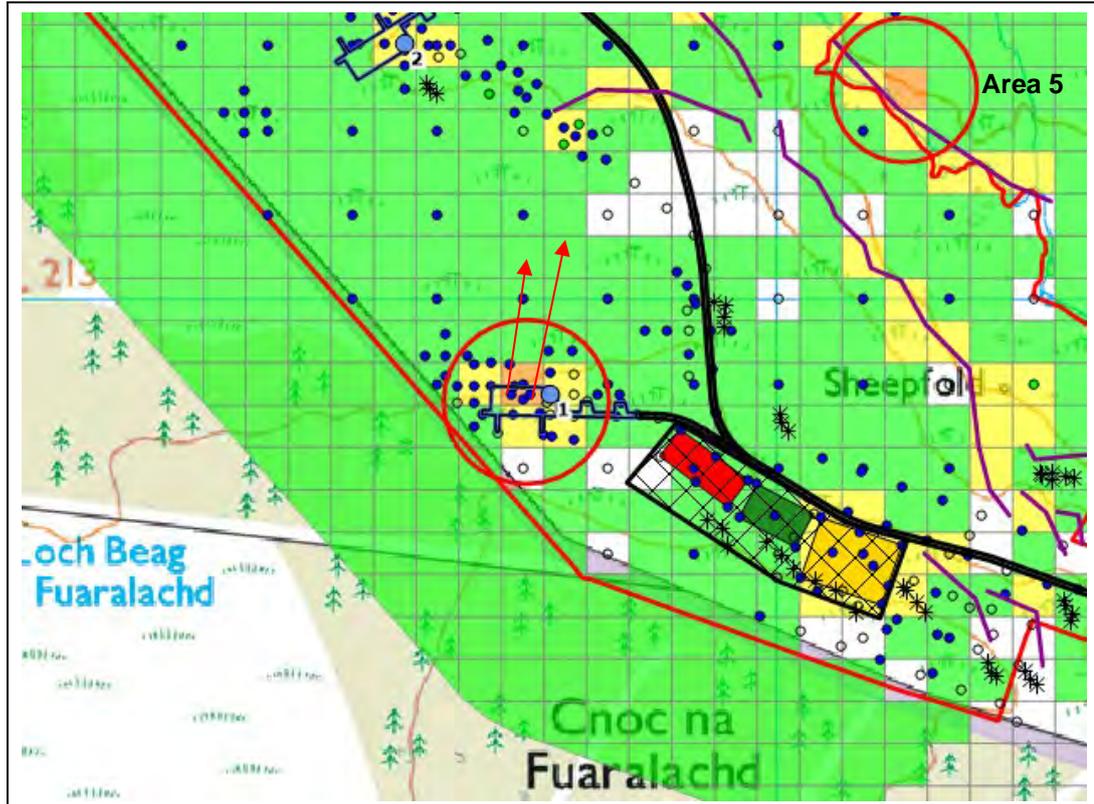
**Area 1:**

One cell at Turbine T1 hardstanding has been assigned Moderate Risk. The cell underlies the northern part of the hardstanding, immediately west of Turbine T1. The assigned risk level relates to the sensitivity of the turbine and its associated Very High consequence rating.

The nearest proposed infrastructure, the access track, is located east of the cell and is out of the direct line of potential effect.

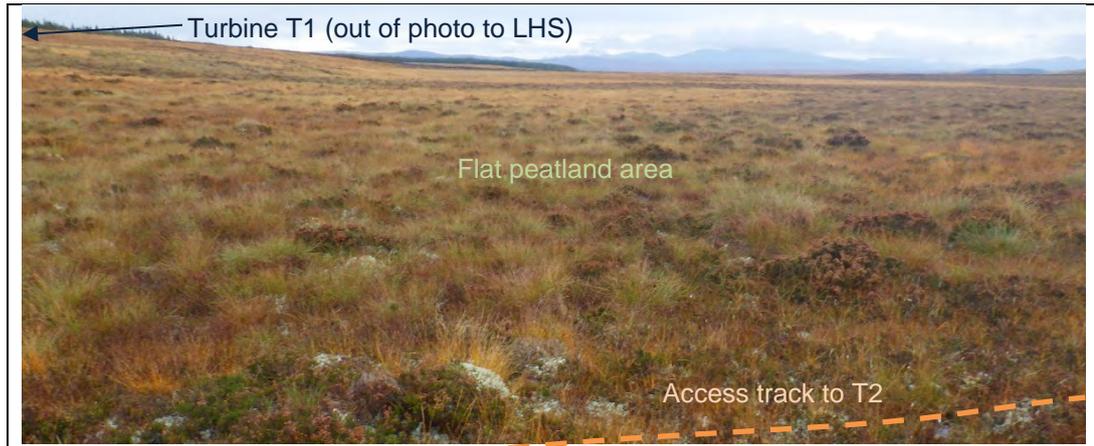
**Photograph looking W across the northern part of Area 1**

The slope north of Turbine T1 has shallow to moderate peat depths no greater than 1.0 m and in many areas <0.5 m. In contrast, the flat peatland area shown above has peat depths mostly deeper than 2.5 m, becoming deeper towards the north (right side of photograph).

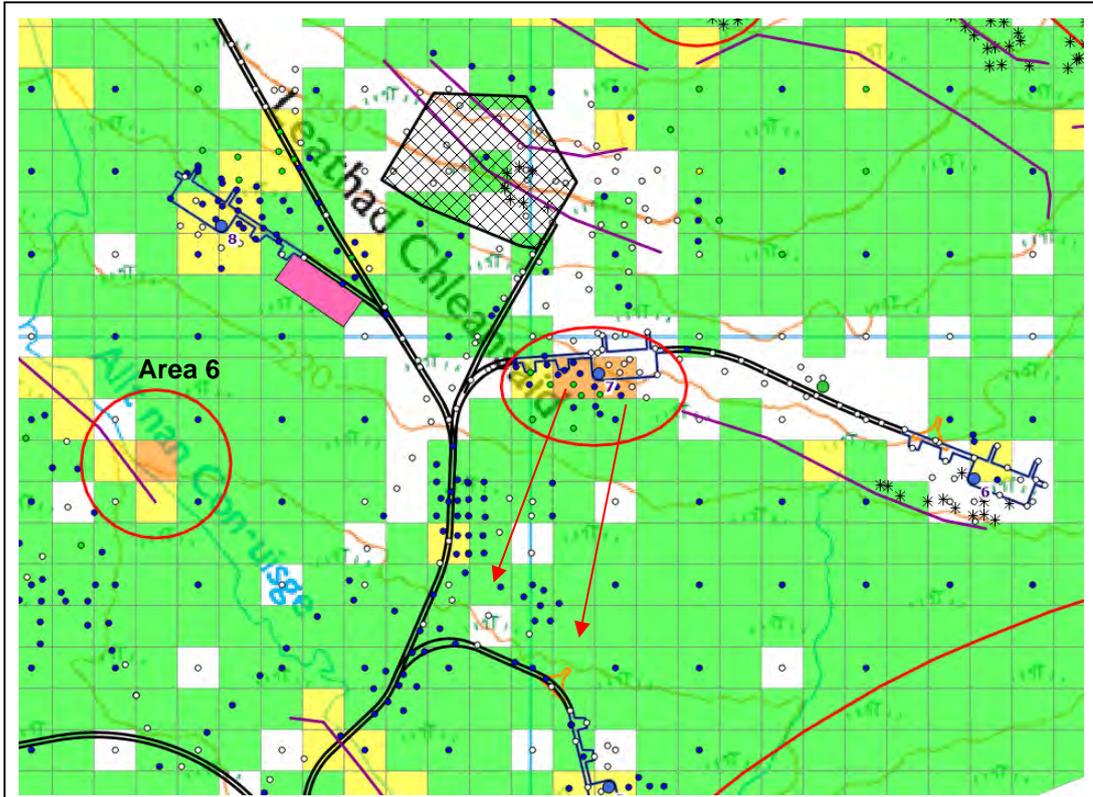
**Area 2:**

Two cells at Turbine T7 and hardstanding have been assigned Moderate Risk. The cells underlie the turbine foundation and much of the hardstanding area. The assigned risk level relates to the sensitivity of the turbine and its associated Very High consequence rating.

It is possible, therefore, that any failure at Turbine T7 could affect the access track to Turbine T5 and possibly also the access route to Turbines T6, T7 and T8 as both track sections are downslope of Turbine T7.

It is very unlikely that Turbine T5 would be directly affected as it is well out of the direct line down the slope.

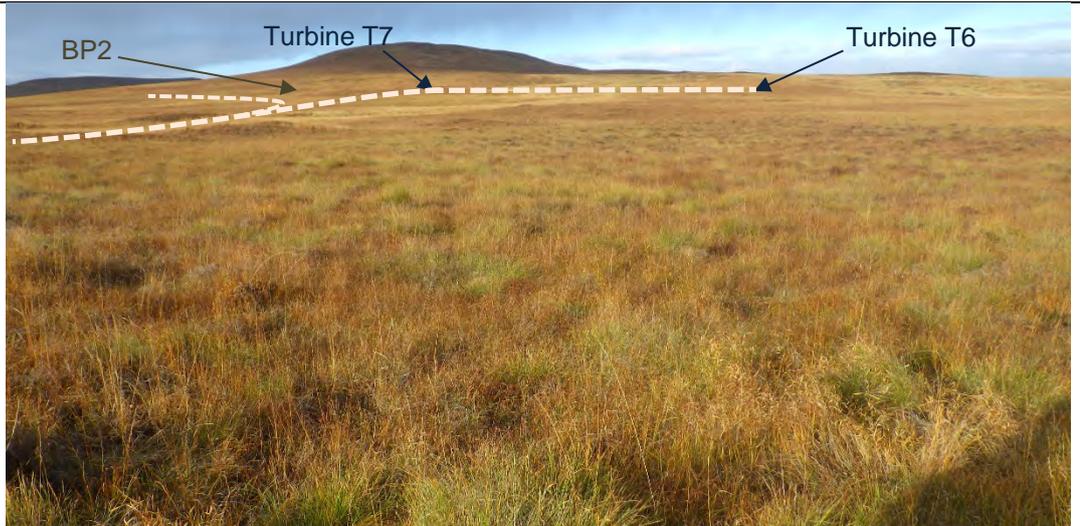
Photograph looking N from Turbine T5 showing the rocky ridge where Turbines T6 and T7 are positioned, and the slight undulations in the slope

The ground at and around Turbine T7 has variable peat and soil depths, ranging from bedrock at surface to >2.5 m approximately 75 m downslope. Turbine T7 and its hardstanding are mainly located in peat or peat soils <1.0 m deep. The deeper peat depth records are all from further down the slope, where the slope angle is gentler. The photograph above shows the small rocky ridge line on which Turbines T7 and T6 are located, with the smoother slope below leading down towards the river.

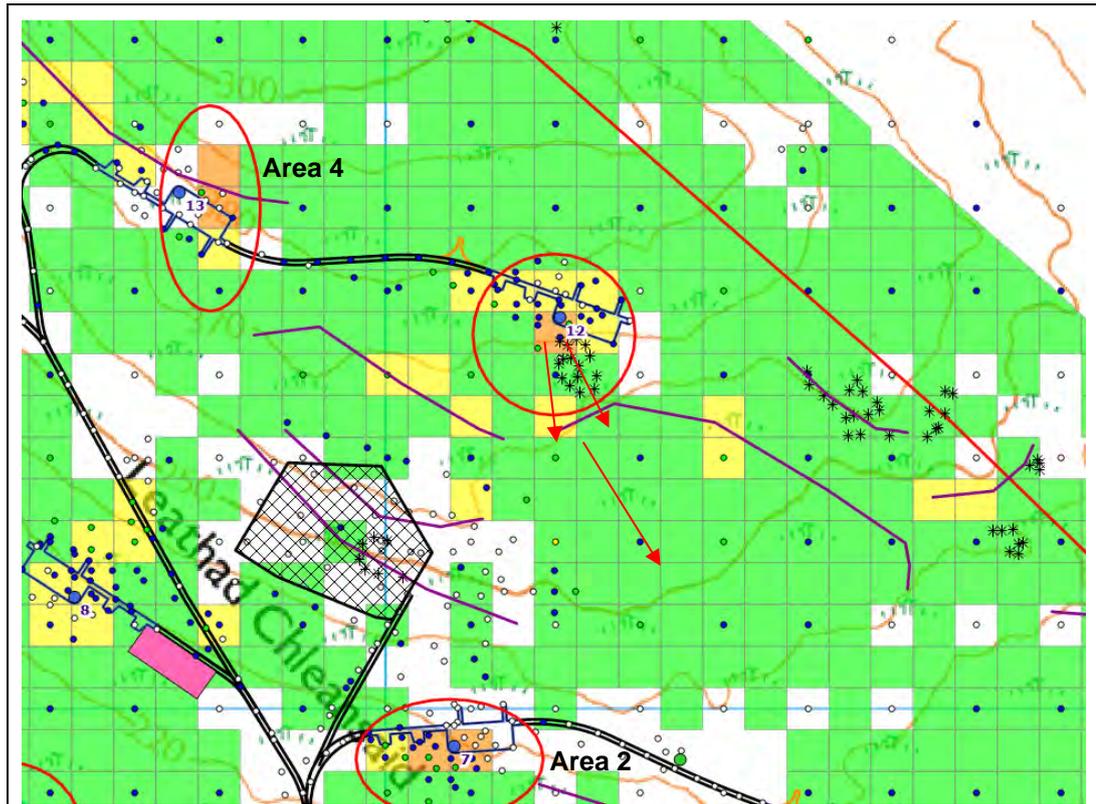
**Area 3:**

One cell at Turbine T12 has been assigned Moderate Risk. The cell underlies part of the turbine foundation. The assigned risk level relates to the sensitivity of the turbine and its associated Very High consequence rating.

It is possible, therefore, that any failure at Turbine T12 could affect Turbine T6 and its associated hardstanding and access track. This is considered to be unlikely given the nature of the intervening ground.

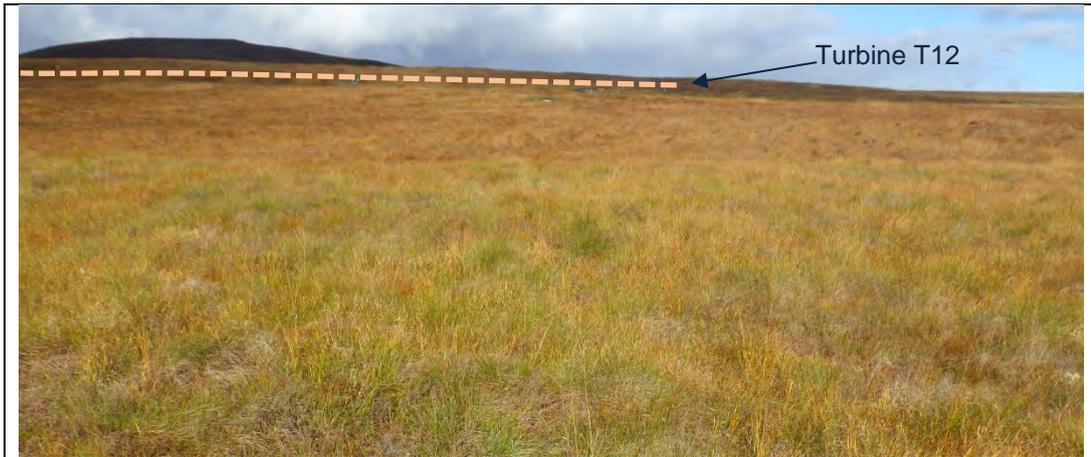
Photograph looking N from Turbine T7 showing the rocky ridge where Turbine T12 is located. The main fall line is to the RHS of the photograph

The ground at and around Turbine T12 has variable peat and soil depths, ranging from bedrock at surface to >2.5 m approximately 40 m downslope. Turbine T12 and its hardstanding are mainly located in peat or peat soils <1.0 m deep. The deeper peat depth records are all from further down the slope, where the slope angle is gentler. The photograph above shows the small rocky ridge line on which Turbine T12 is located, with the smoother slope below leading down towards Turbine T7 and the River Brora.

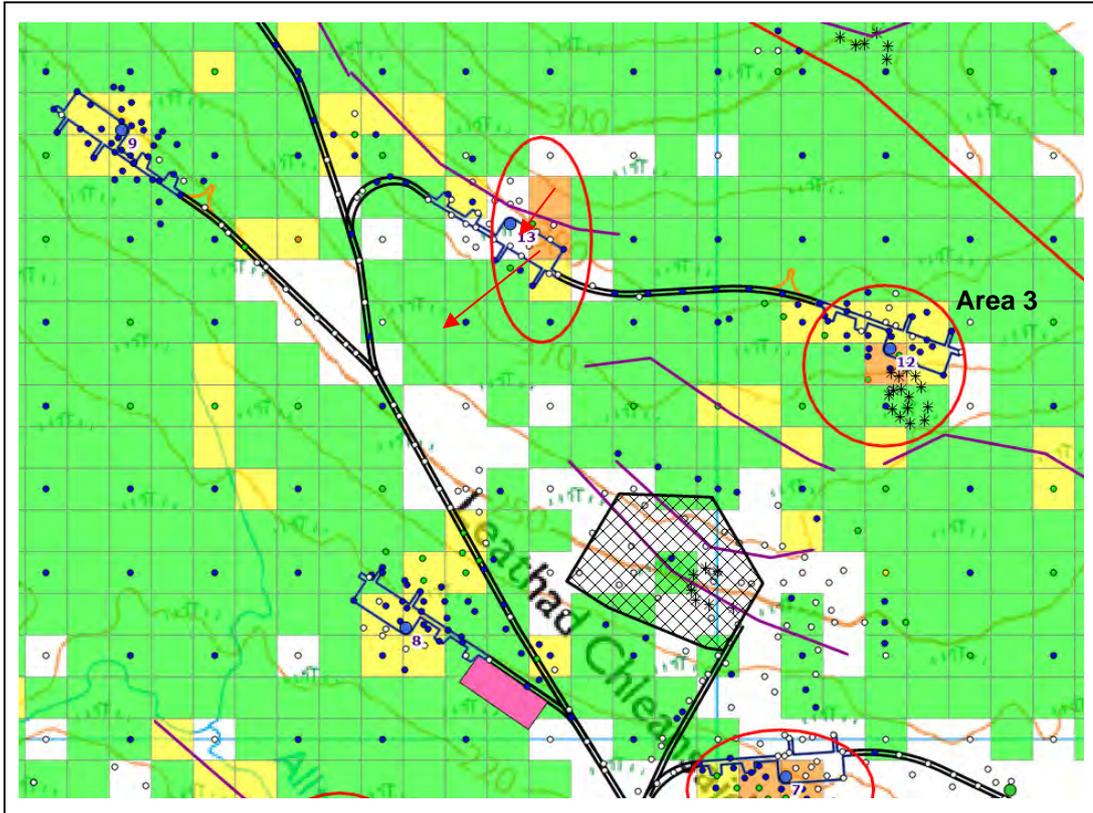
**Area 4:**

Two cells at Turbine T13 have been assigned Moderate Risk. The cells underlie part of the crane hardstanding. The assigned risk level relates to the sensitivity of the turbine and its associated Very High consequence rating.

Any failure at Turbine T13 is likely to affect the section of access track between Turbines T8 and T9, as this lies downslope of the turbine area.

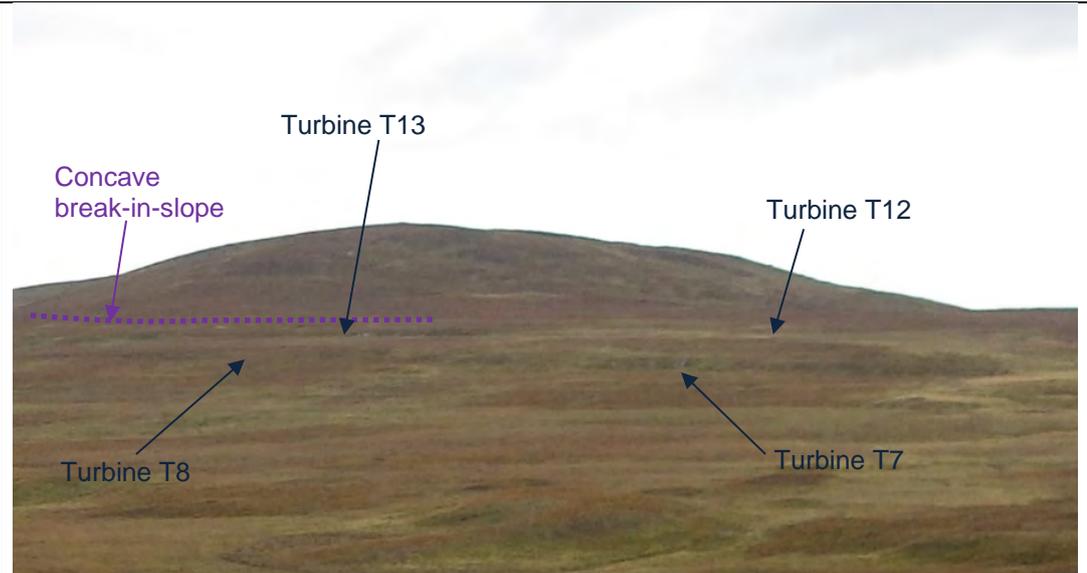
Photograph looking N from near Turbine T1 to Sròn Leathad Chleansaid, giving an overview of the slope around Turbines T12 and T13.

Turbine T13 is located a short distance below a distinct concave break-in-slope that marks the change from the steep ground on Leathad Chleansaid to the more gentle ground between the main ridge and the river.

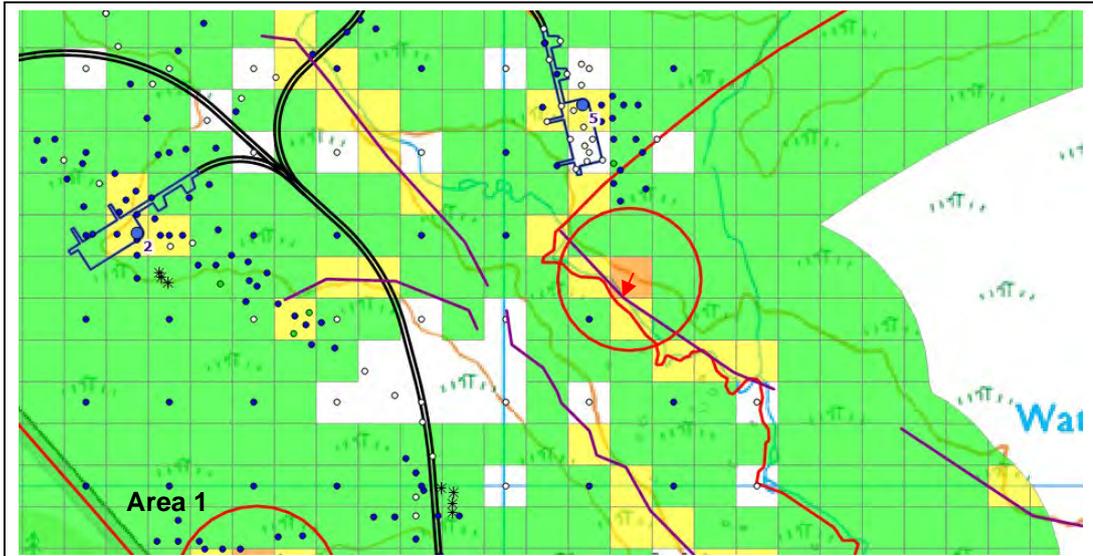
**Area 5:**

One cell south of Turbine T5 has been assigned Moderate Risk. The cell is not associated with any proposed infrastructure and lies outwith the planning application boundary. The risk level relates to the High consequence rating assigned to all watercourses and the Likely likelihood rating arising as a result of the break-in-slope associated with the watercourse valley.

*Potential runout from any failure:* Any failure in this area would terminate in the Allt nan Con-uisge. Runout distances would be up to 50 m as the risk area is adjacent to the watercourse. Any failure may be entirely outwith the application boundary. No indications of peat instability or developing instability were recorded in nearby areas during the peat depth and reconnaissance surveys.

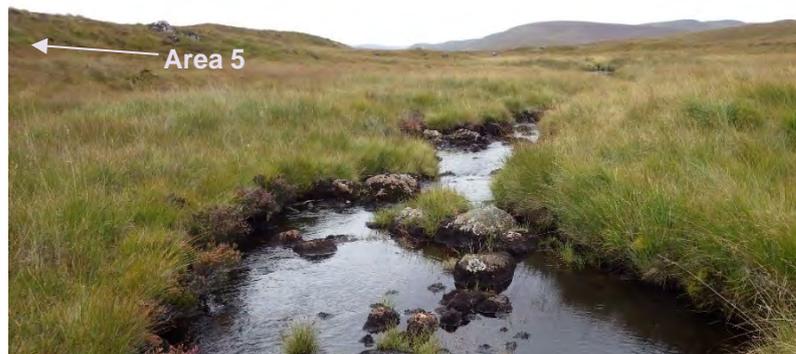
Photograph looking SE (downstream) along the Allt nan Con-uisge near Area 5

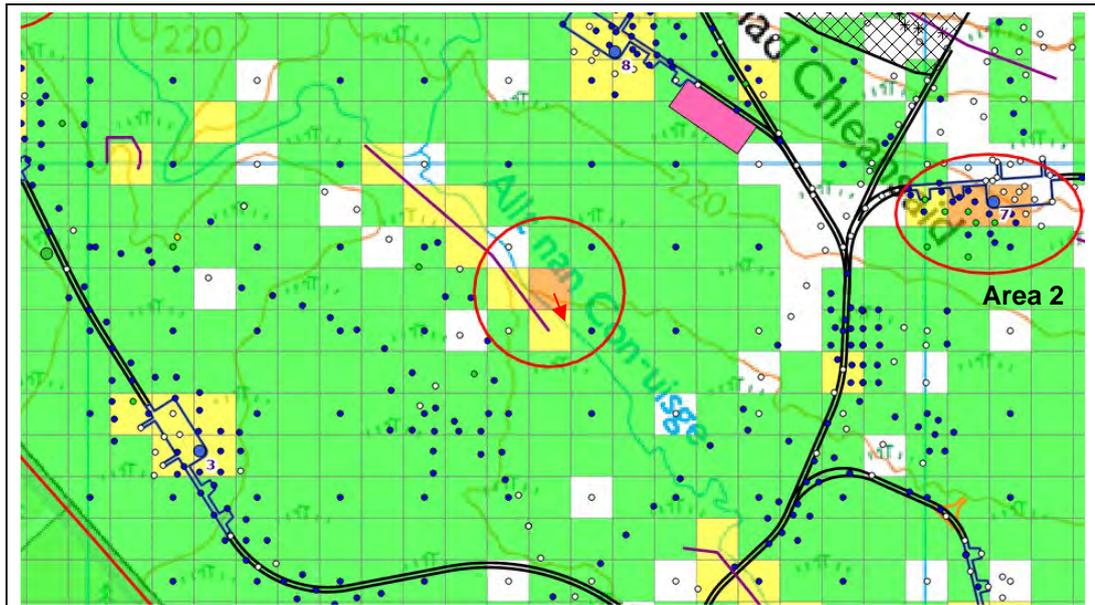
**Area 6:**

One cell on the Allt nan Con-uisge between Turbines T3 and T8 has been assigned Moderate Risk. The cell is not associated with any proposed infrastructure. The risk level relates to the High consequence rating assigned to all watercourses and the Likely likelihood rating arising as a result of the break-in-slope associated with the watercourse valley.

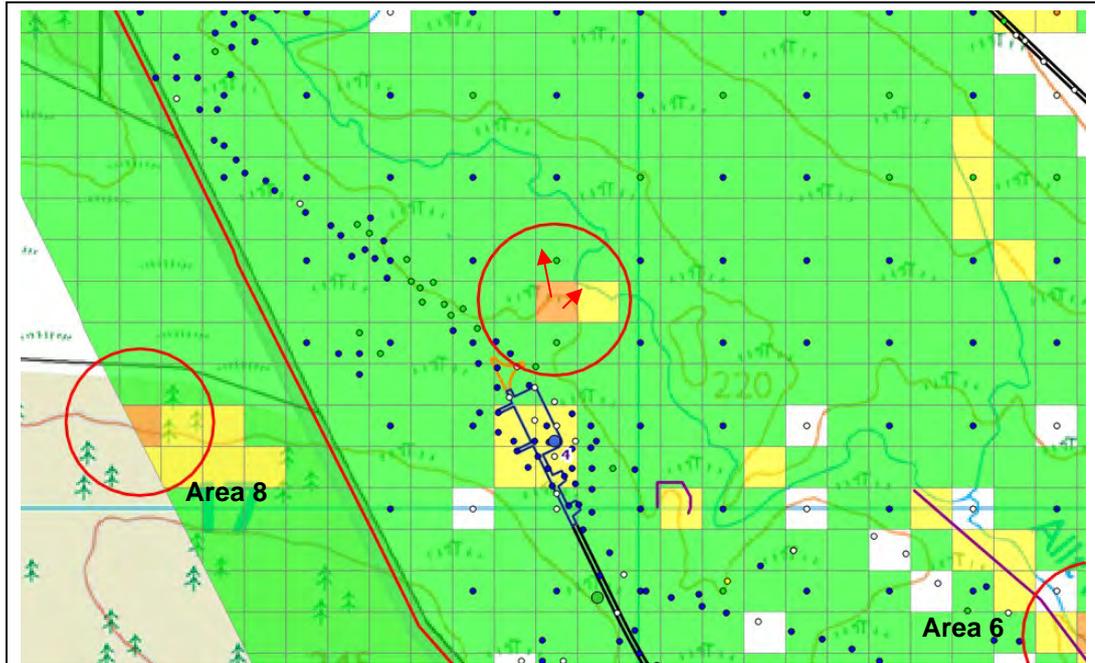
**Area 7:**

One cell near Turbine T4 has been assigned Moderate Risk. The cell is not associated with any proposed infrastructure. The risk level relates to the High consequence rating assigned to all watercourses and the Likely likelihood rating arising as a result of the small but locally steep hill present in this area.

*Potential runout from any failure:* Any failure in this area would terminate in the Allt nan Con-uisge or on the nearby flat area of peat bog. Runout distances may be up to 100 m. No indications of peat instability or developing instability were recorded in nearby areas during the peat depth and reconnaissance surveys.

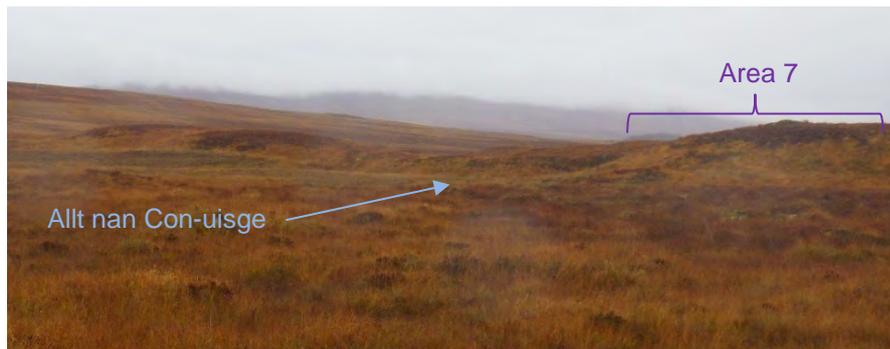
Photograph looking SE to Area 7 and downstream along the Allt nan Con-uisge

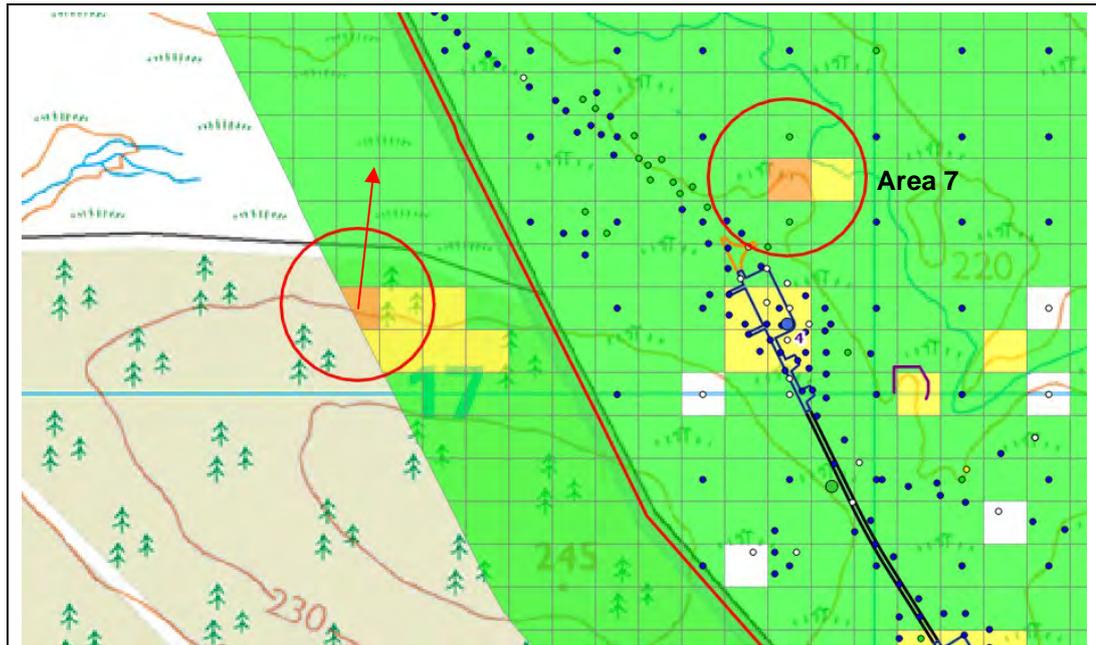
**Area 8:**

One cell west Turbine T4 has been assigned Moderate Risk. The cell is not associated with any proposed infrastructure and lies completely outwith the planning application boundary. The risk level relates to the Very High likelihood rating assigned to this cell.

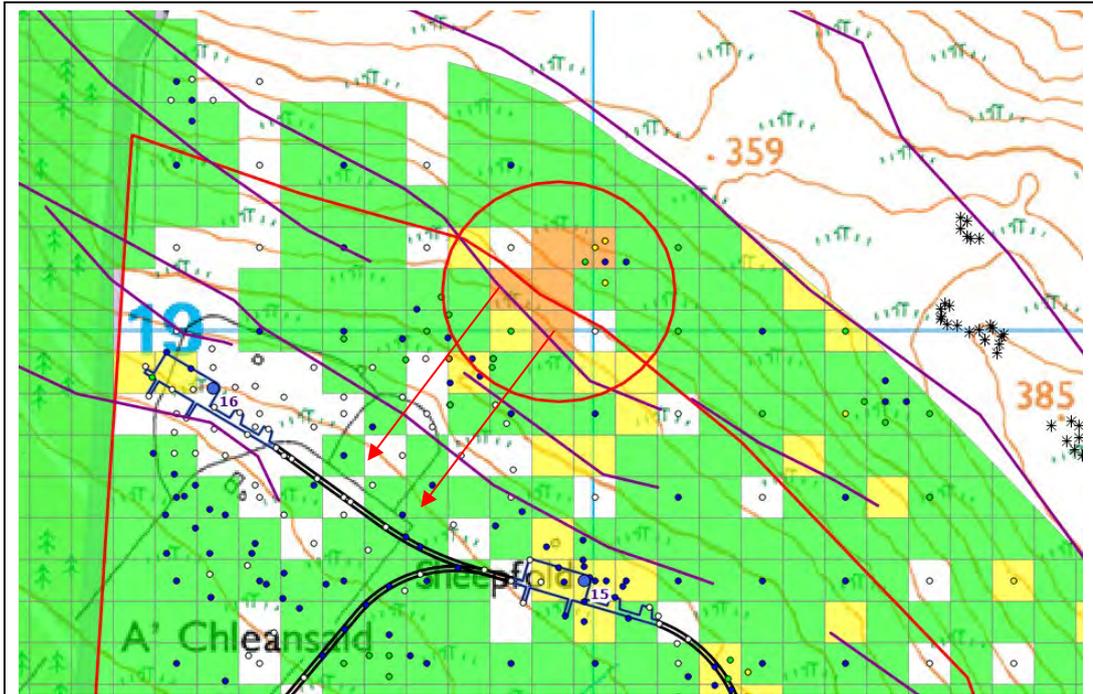
**Area 9:**

Five cells on the side of Leathad Chleainsaid have been assigned Moderate Risk. The cells are not directly associated with any proposed infrastructure and lie across the planning application boundary. The risk level relates to the Very High likelihood ratings assigned to these cells.

*Potential runout from any failure:* Any failure in this area would have a runout zone heading south-west with a probable termination area around the channel of the tributary to the Abhainn Sgeamhaidh downslope from A' Chleainsaid farmstead. A failure in this area is likely to affect the access track between Turbines T15 and T16, and may also affect the track section down to Turbine T10. Runout distances of around 800-900 m would be possible. No indications of peat instability or developing instability were recorded in nearby areas during the peat depth and reconnaissance surveys.

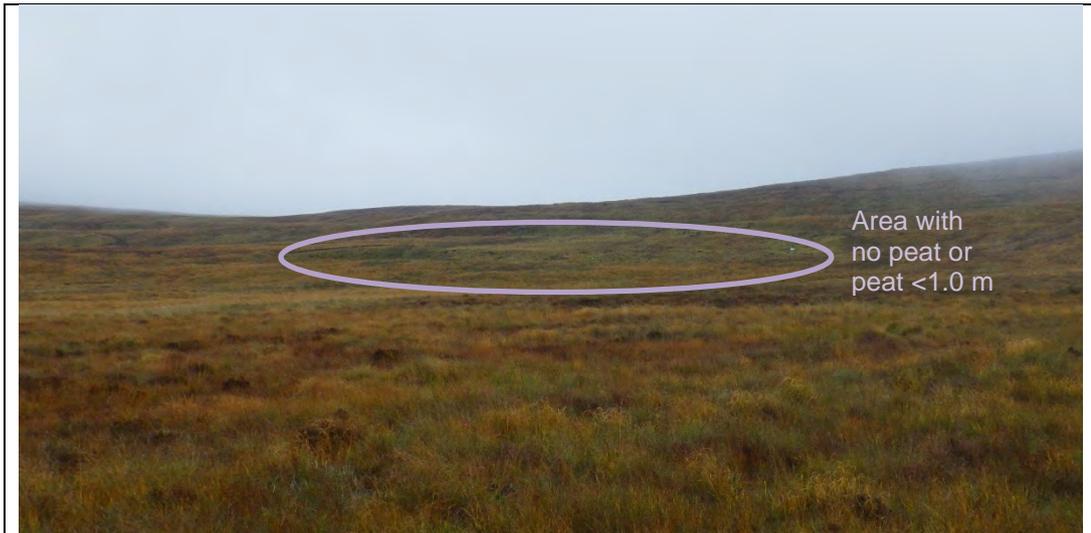
Photograph looking N from Turbine T15 towards the col between Sròn Leathad Chleansaid and Creag Dhubh

It is likely that the interpolated peat depth considerably over-estimates the actual peat depth on the slopes, as records from adjacent areas of the slope with similar slope angles have either no peat or peat typically less than 1.0 m with occasional deeper records. The deep peat records from the north-easternmost cell coincide with much shallower slope angles, and this peat is indicated to form a small isolated pocket on the side of the col between Sròn Leathad Chleansaid and Creag Dhubh.
